the **play inspection** company

Annual Inspection

Ringshall Village Hall

Inspection Ref: 2606211

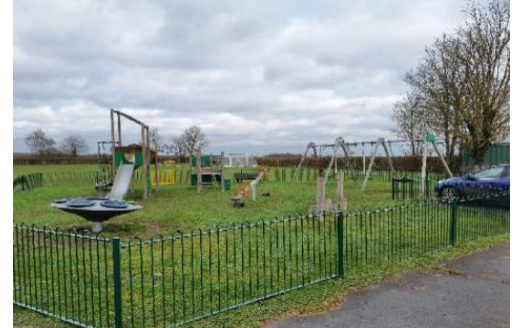
The grass mats are silted up, the soil is compacted and the area will become very slippery when the soil is wet. - Reinststate as required

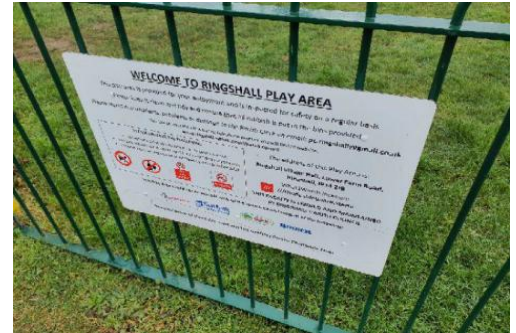
There are projecting bolt thread(s) present - Remove excess thread length and deburr or provide cap

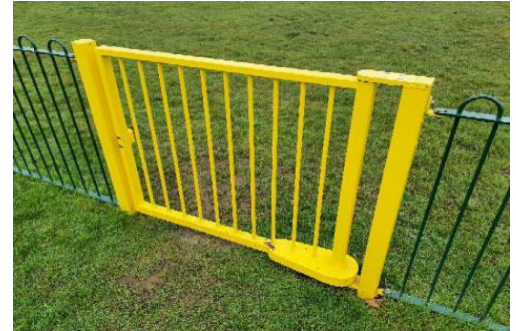
The surface has eroded in some areas and may be slippery in wet conditions - Reinstate the surface

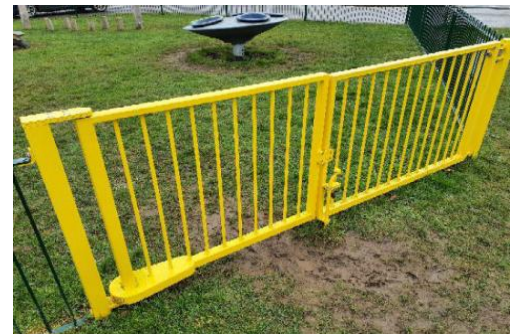
The surface has eroded in some areas and may be slippery in wet conditions - Reinstate the surface

The maintenance gate was correctly padlocked at the time of inspection, however this means that the inspector was unable to fully assess the gate - Ensure that there are 12mm gaps throughout the full range of motion on gate/s and between leaves where relevant

The gate is closing too quickly (less than 4 seconds) - Take corrective action to ensure that the gate closes in 4-8 seconds from 90 degrees

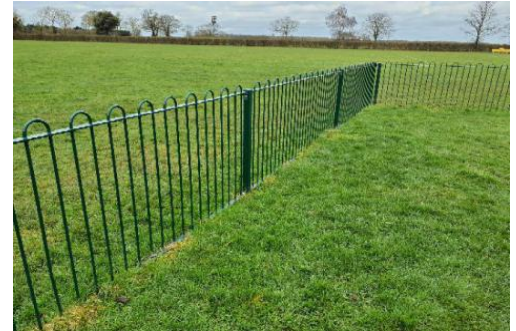
Shear nuts have not been fully tightened and are still present on fixings - Tighten heads on nuts to shear off and secure

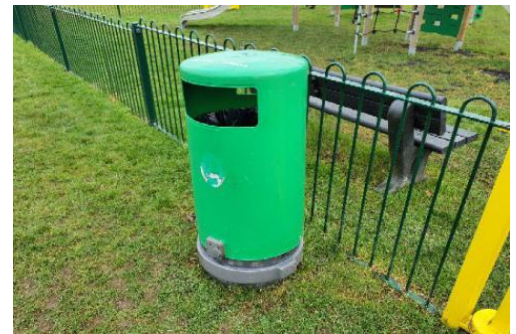
The lid or door of the litter bin is not secured - Ensure the lid or door is kept locked

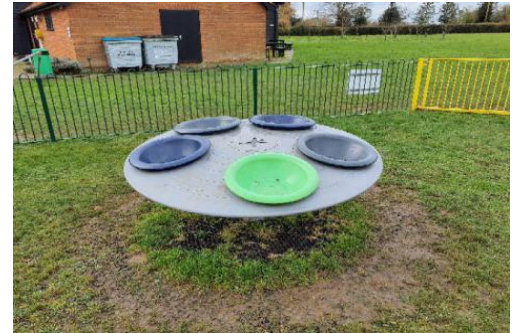
There is weed / vegetation growth within the surface - Remove weed / vegetation growth

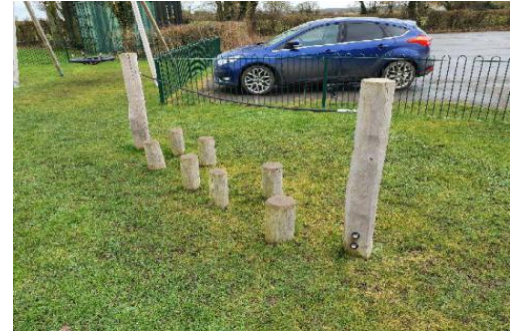
There are splits running through the timber that cross through or near fixing points and may cause instability in the future
 - Monitor stability of fixings

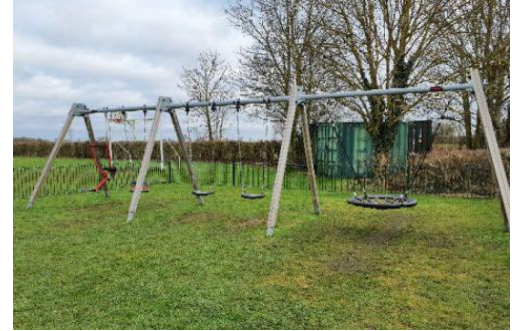
The suspension lugs are showing signs of wear - Monitor for any further deterioration and repair as required

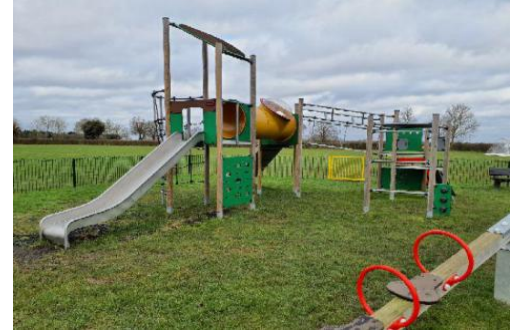
There is/are bolt cap covers missing or damaged on the item and are loose - Replace missing or damaged bolt cap covers

The slide is predominately south facing and will catch the majority of the sun's heat during the day. Slide surfaces can become very warm during periods of sustained sunny weather - Monitor - No action given the risk assessment

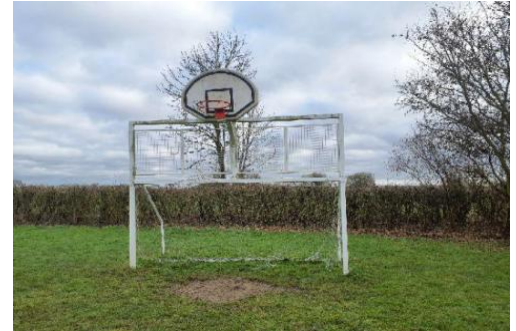
A clearly visible facility sign should be provided in a prominent position with the wording as detailed BS EN 15312- the equipment is not intended for children less than 3 years old- the warning - Do not climb on the framework or nets- the warning - Do not hang on the ring (if provided)- the warning - Do not wear rings or other jewellery- name and telephone number of the administrator- number to call in case of accident - Provide signage to BS EN 15312

The surface has eroded in some areas and may be slippery in wet conditions - Reinstate the surface

The item fails to meet the requirements of BS EN 15312 4.4.2.1 head and neck entrapment in the frame - Monitor - No action given the risk assessment

The weld(s) on this item have failed - Repair item

There are projecting bolt thread(s) present - Remove excess thread length and deburr or provide cap

The net is damaged and unsecured - Replace damage net and secure fully

The item is slightly loose in its foundations - Monitor for any further deterioration and repair as required

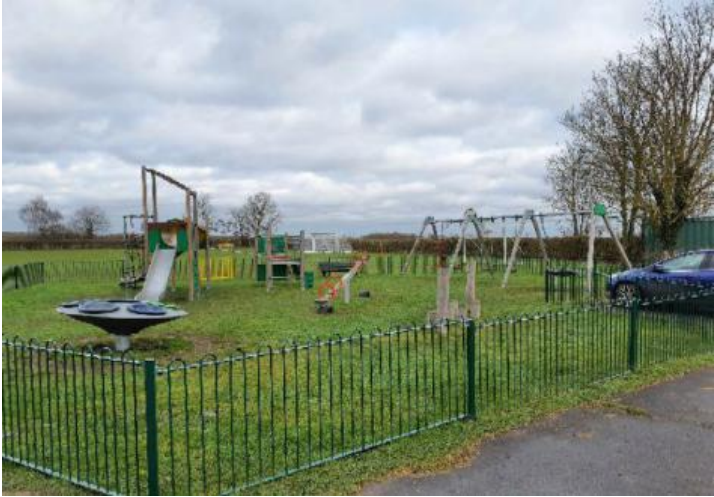
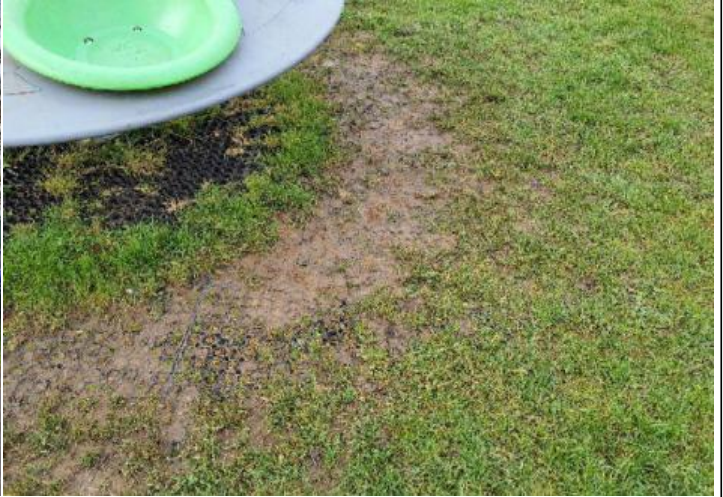
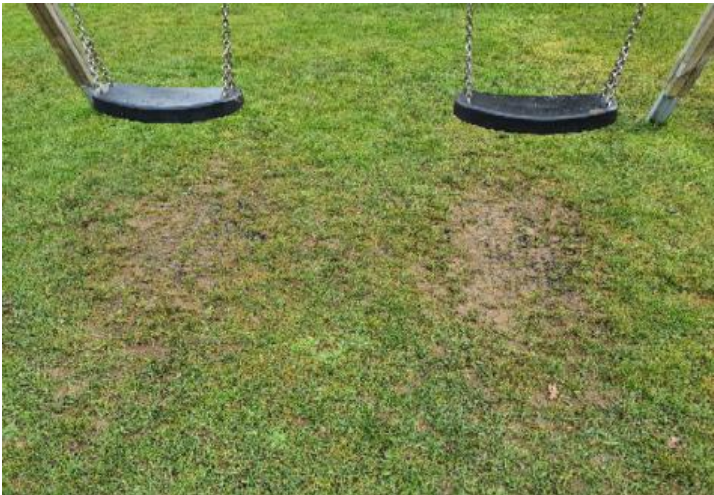
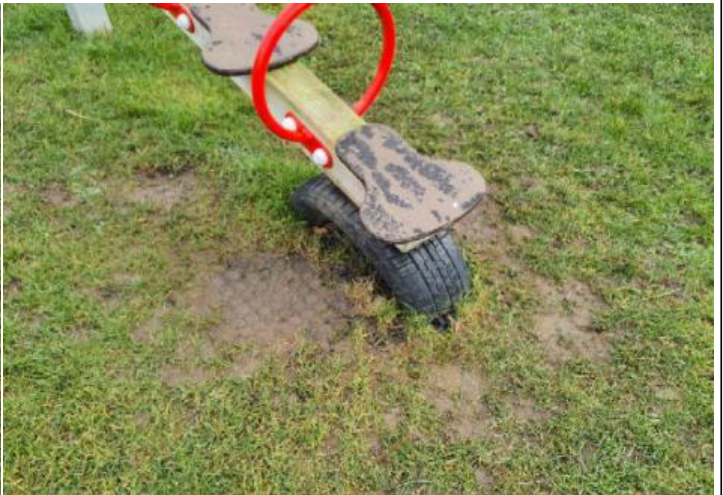
Finding: The grass mats are silted up, the soil is compacted **Action:** Reinstate as required and the area will become very slippery when the soil is wet.

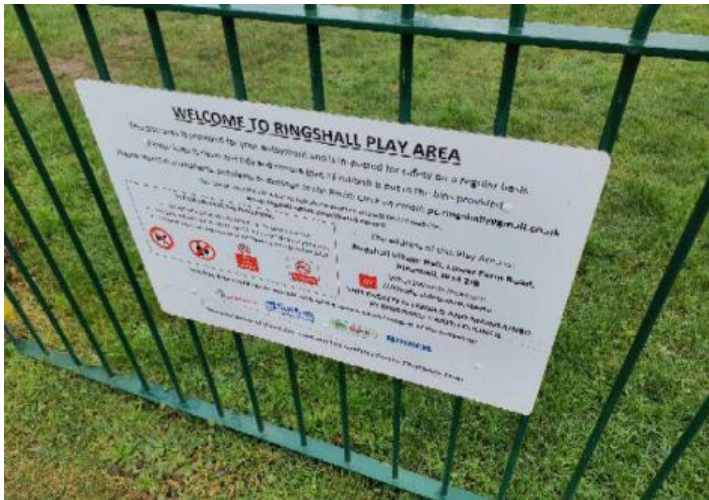
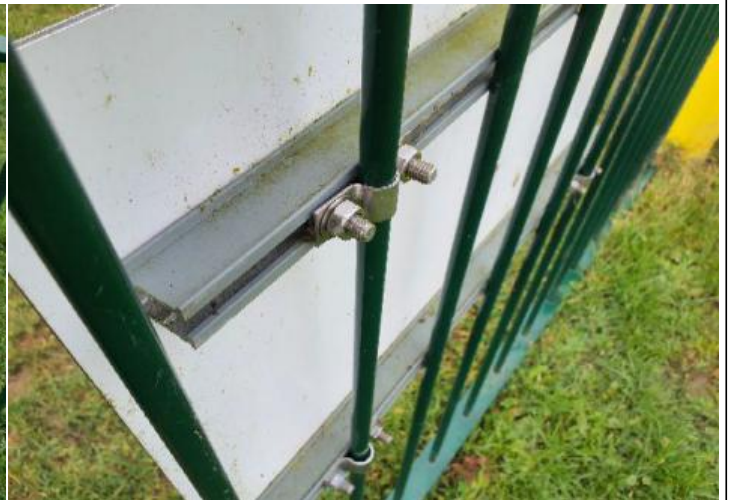
Finding: There are projecting bolt thread(s) present

Action: Remove excess thread length and deburr or provide cap

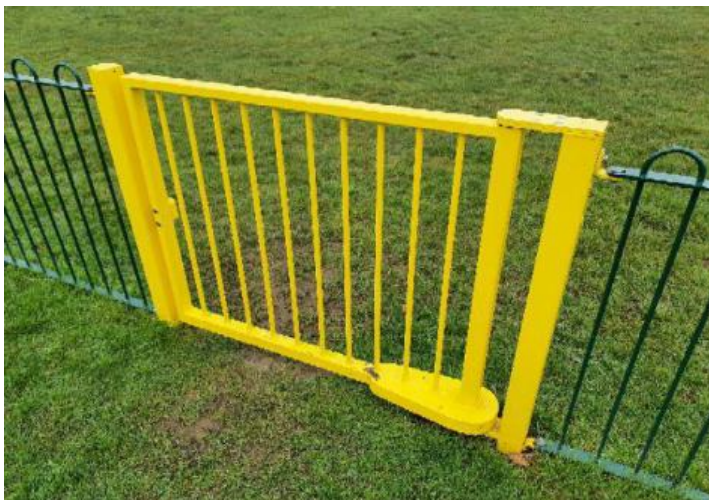
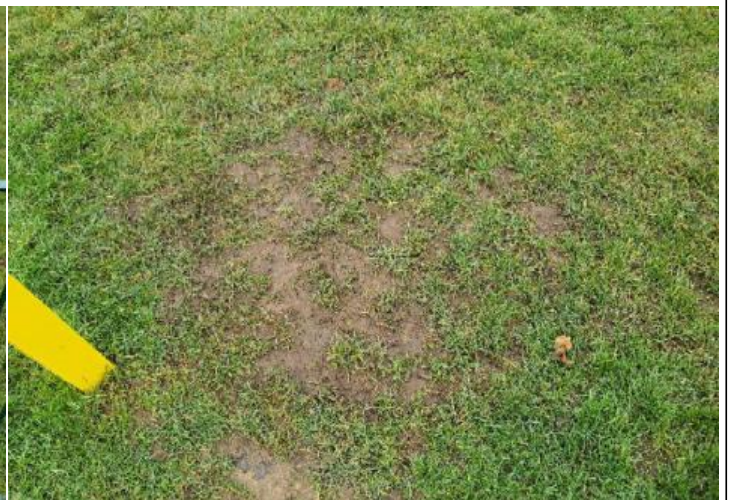
Finding: The surface has eroded in some areas and may be slippery in wet conditions

Action: Reinstate the surface

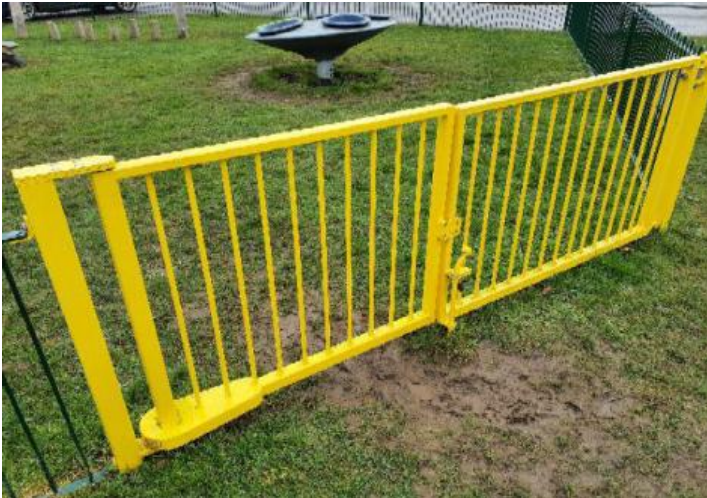
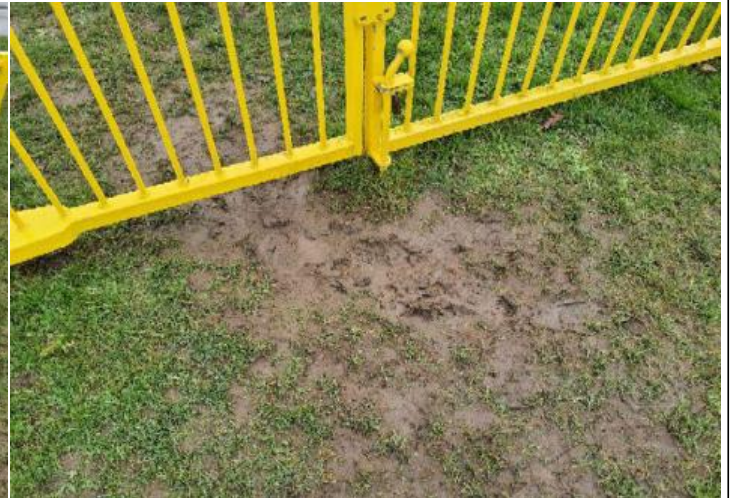
Finding: The surface has eroded in some areas and may be slippery in wet conditions
Action: Reinstate the surface

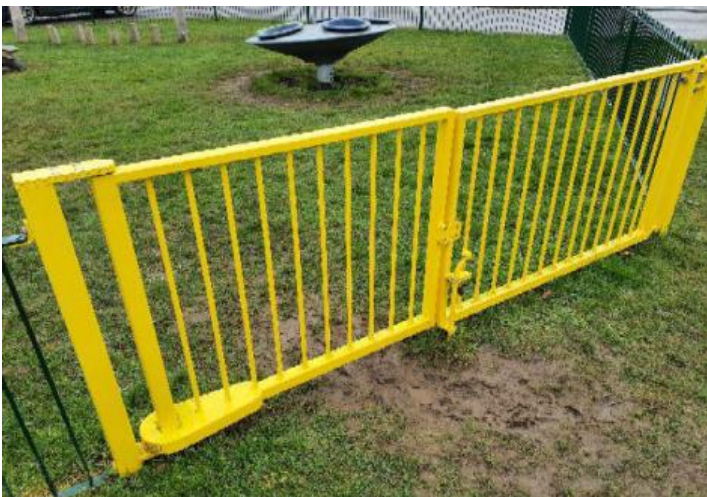
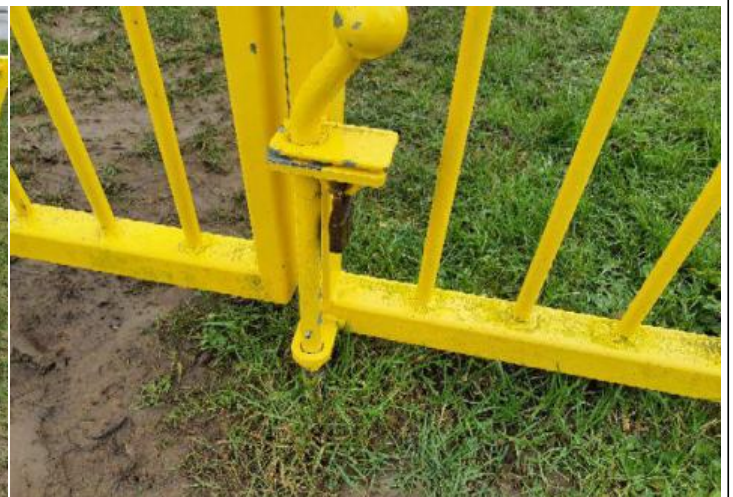
Finding: The maintenance gate was correctly padlocked at the time of inspection, however this means that the inspector was unable to fully assess the gate
Action: Ensure that there are 12mm gaps throughout the full range of motion on gate/s and between leaves where relevant

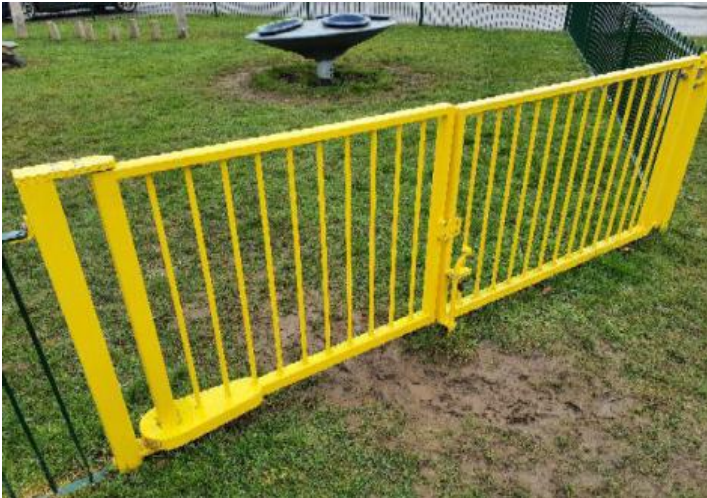
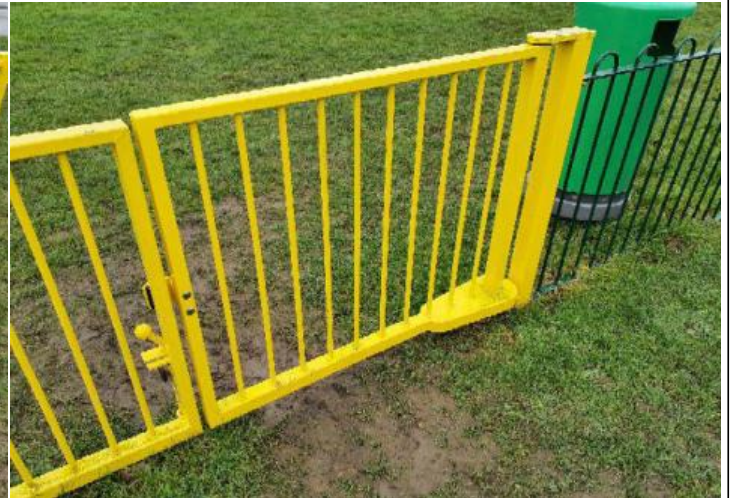
Finding: The gate is closing too quickly (less than 4 seconds)

Action: Take corrective action to ensure that the gate closes in 4-8 seconds from 90 degrees

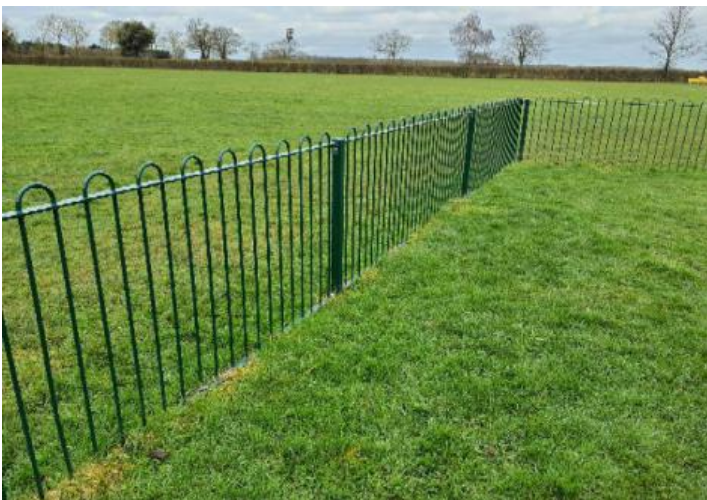
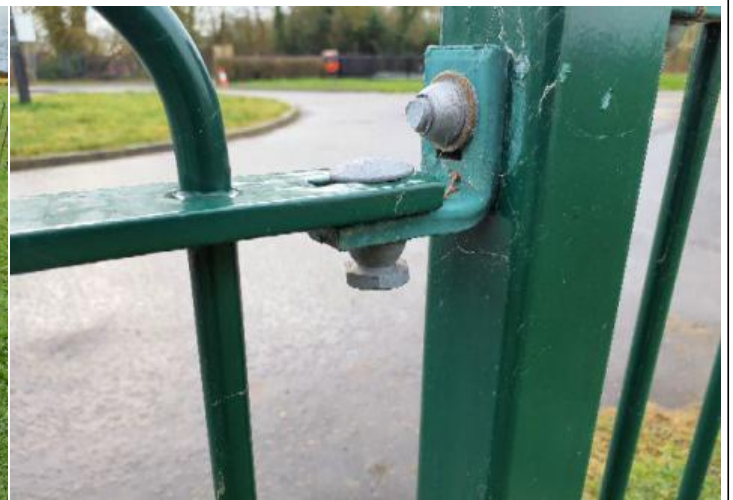
Finding: Shear nuts have not been fully tightened and are still present on fixings

Action: Tighten heads on nuts to shear off and secure

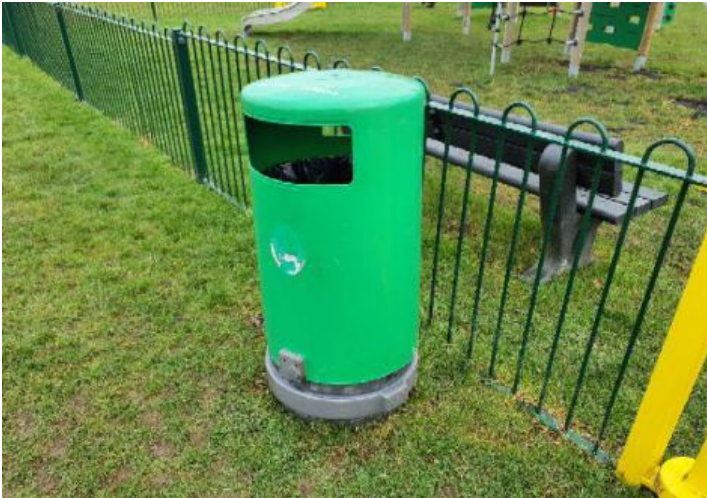
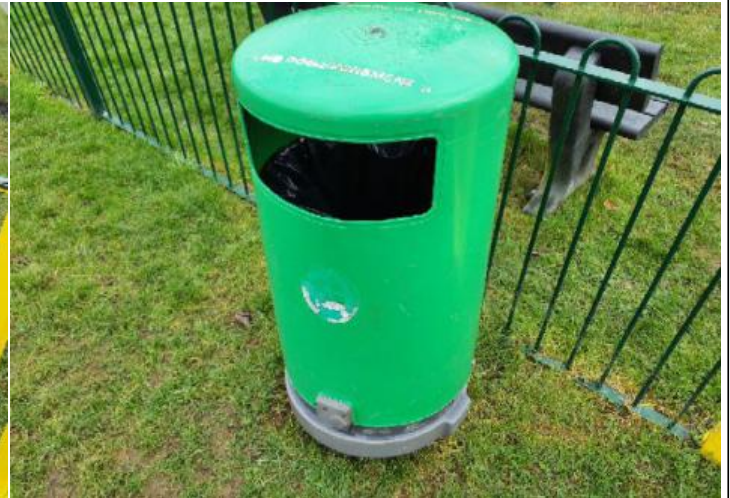
Finding: The lid or door of the litter bin is not secured

Action: Ensure the lid or door is kept locked

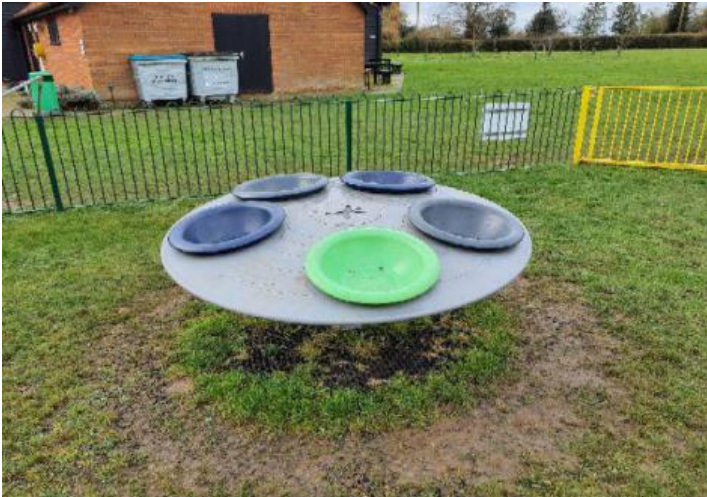
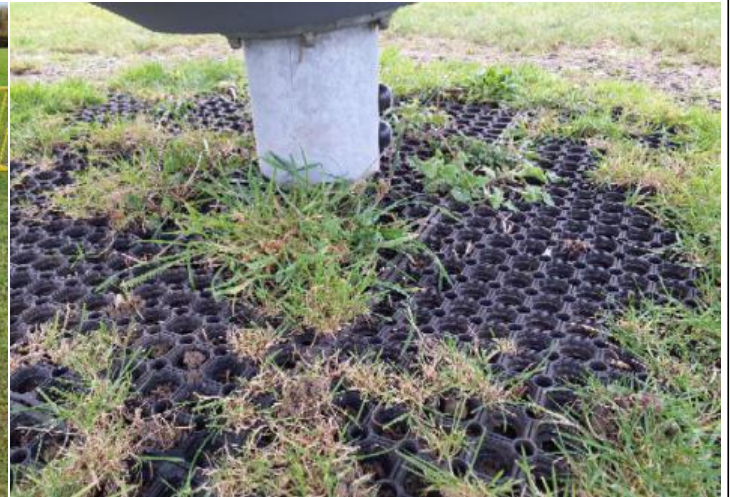
Finding: There is weed / vegetation growth within the surface

Action: Remove weed / vegetation growth

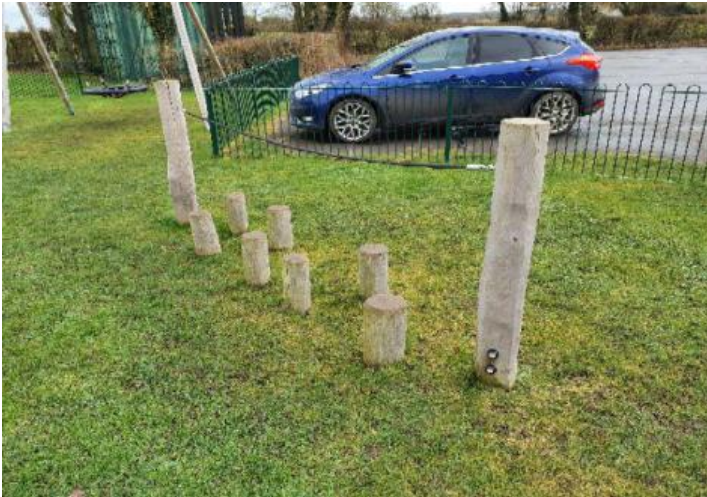
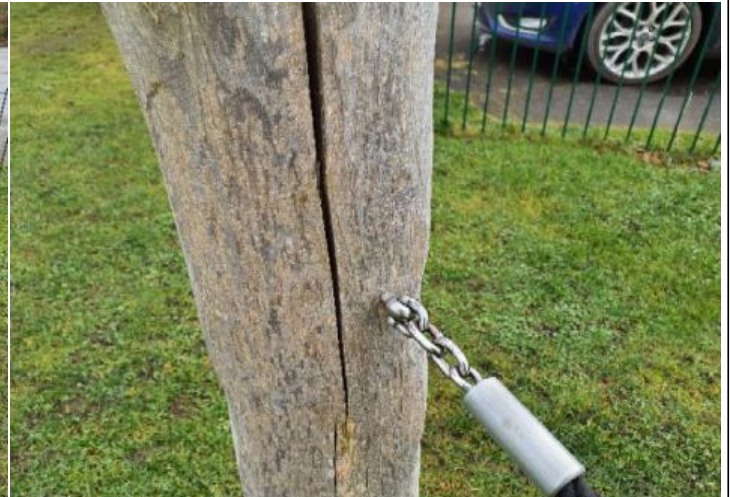
Finding: There are splits running through the timber that cross through or near fixing points and may cause instability in the future

Action: Monitor stability of fixings

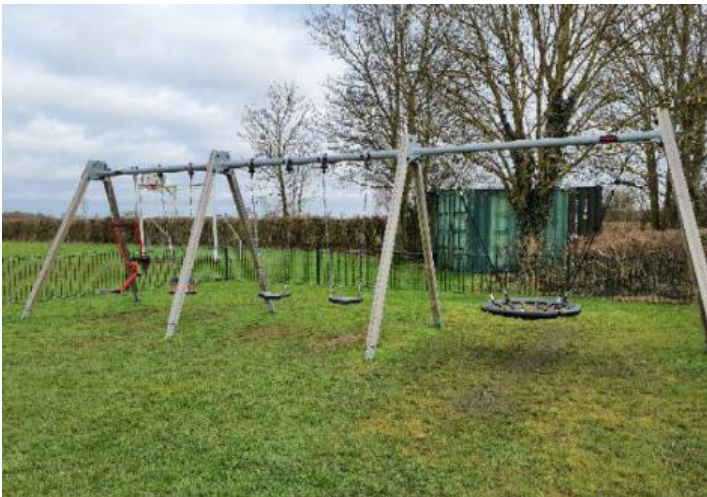
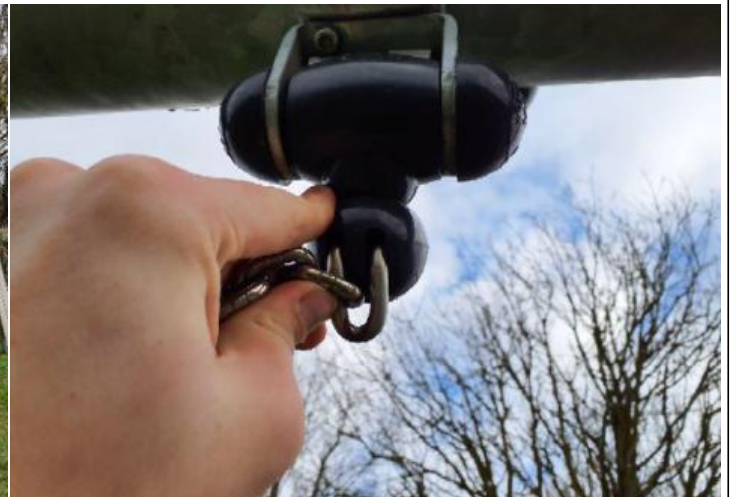
Finding: The suspension lugs are showing signs of wear

Action: Monitor for any further deterioration and repair as required

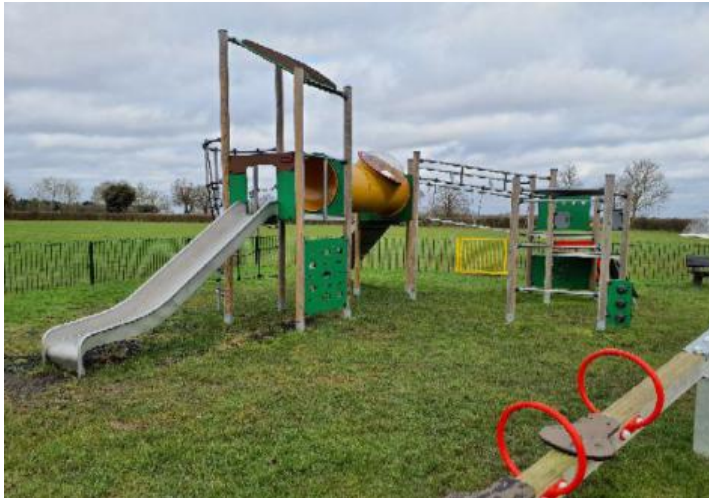
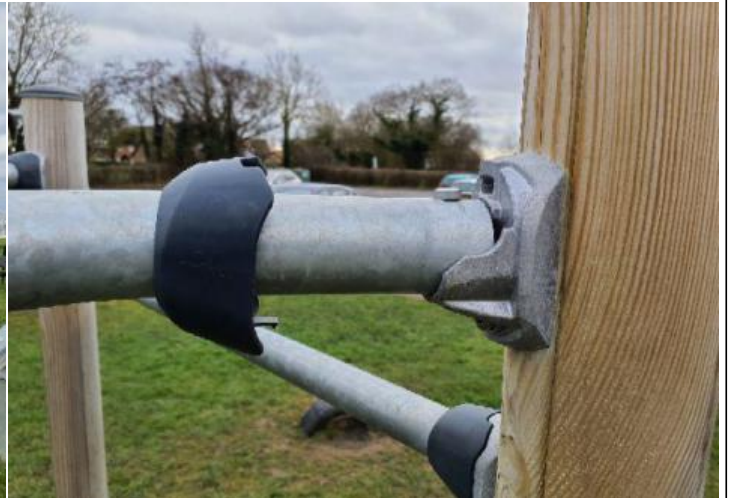
Finding: There is/are bolt cap covers missing or damaged on the item and are loose

Action: Replace missing or damaged bolt cap covers

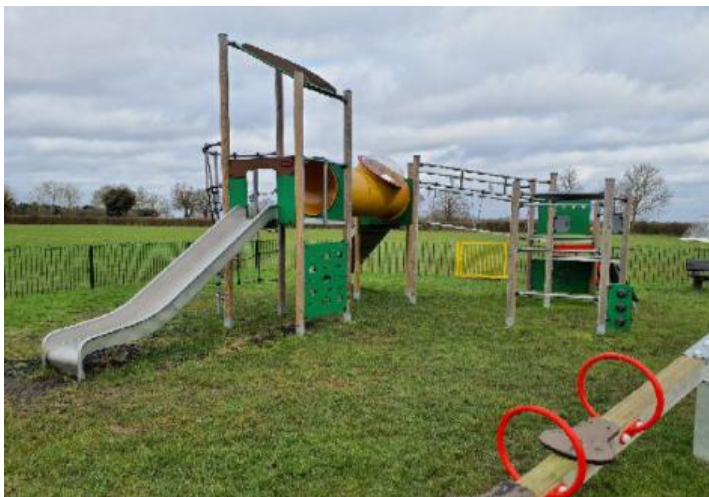
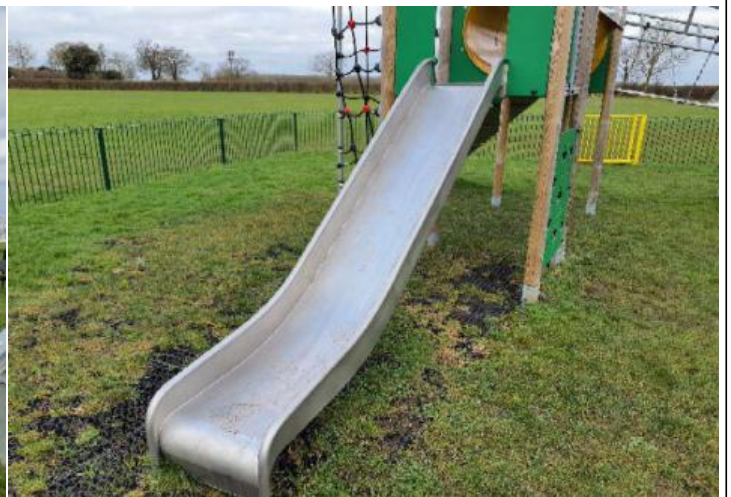
Finding: The slide is predominately south facing and will catch the majority of the sun's heat during the day. Slide surfaces can become very warm during periods of sustained sunny weather

Action: Monitor - No action given the risk assessment

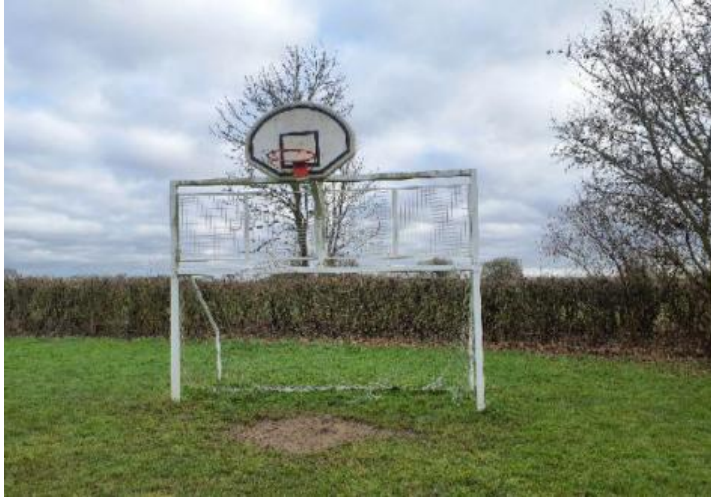
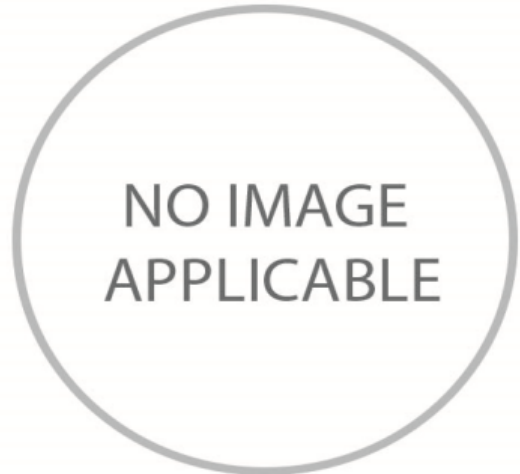
Finding: A clearly visible facility sign should be provided in a prominent position with the wording as detailed BS EN 15312- the equipment is not intended for children less than 3 years old- the warning - Do not climb on the framework or nets- the warning - Do not hang on the ring (if provided)- the warning - Do not wear rings or other jewellery- name and telephone number of the administrator- number to call in case of accident

Action: Provide signage to BS EN 15312

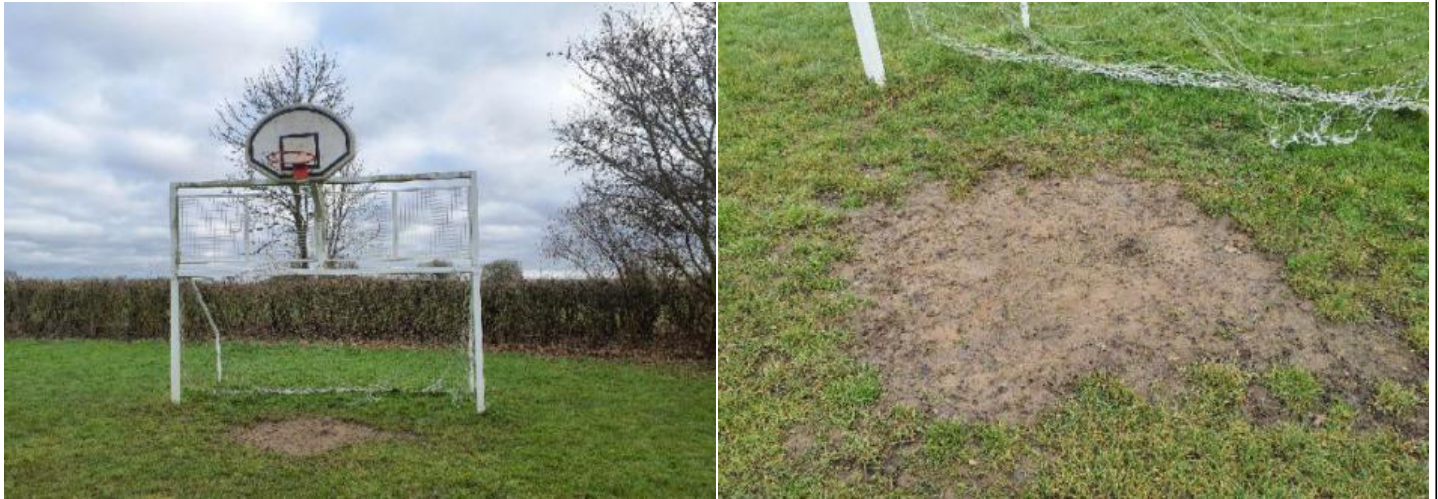
Finding: The surface has eroded in some areas and may be slippery in wet conditions
Action: Reinstate the surface

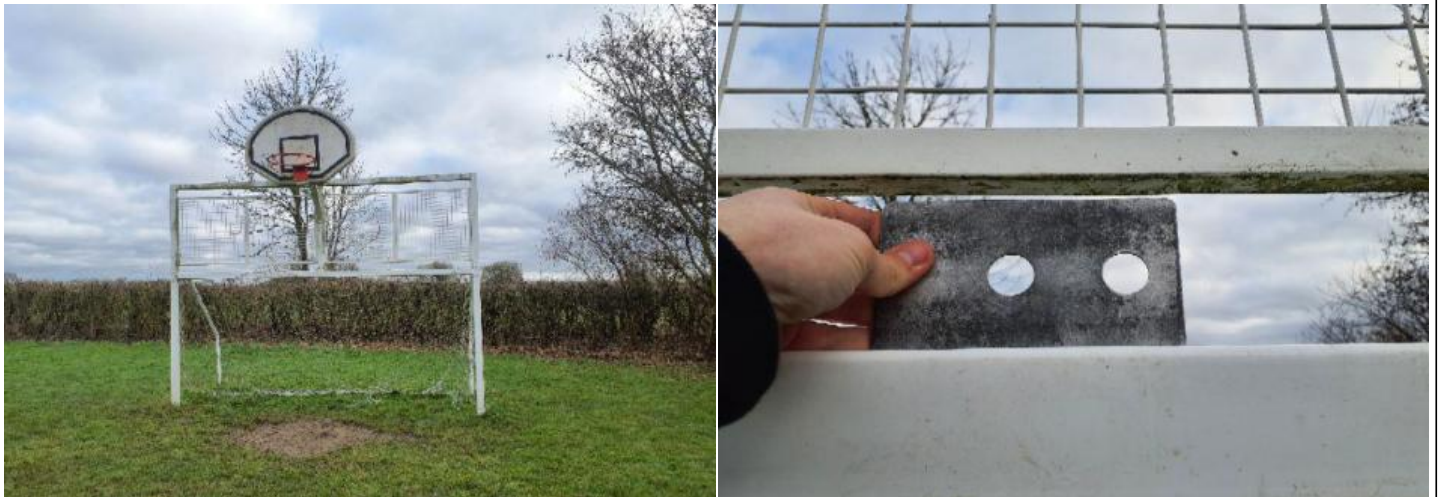
Finding: The item fails to meet the requirements of BS EN 15312 4.4.2.1 head and neck entrapment in the frame
Action: Monitor - No action given the risk assessment

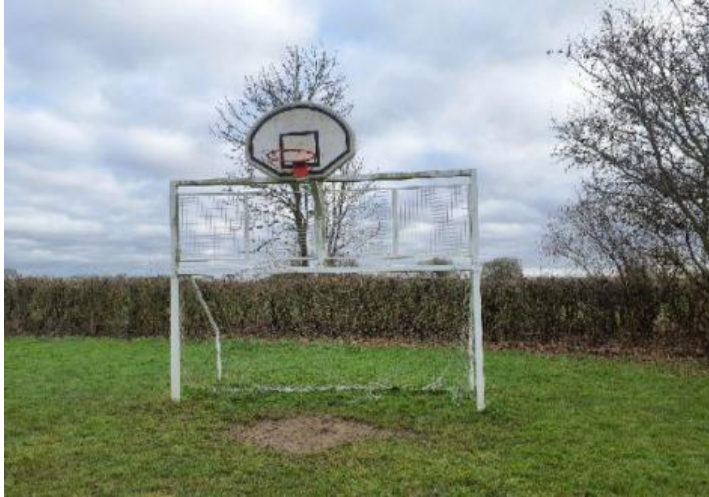
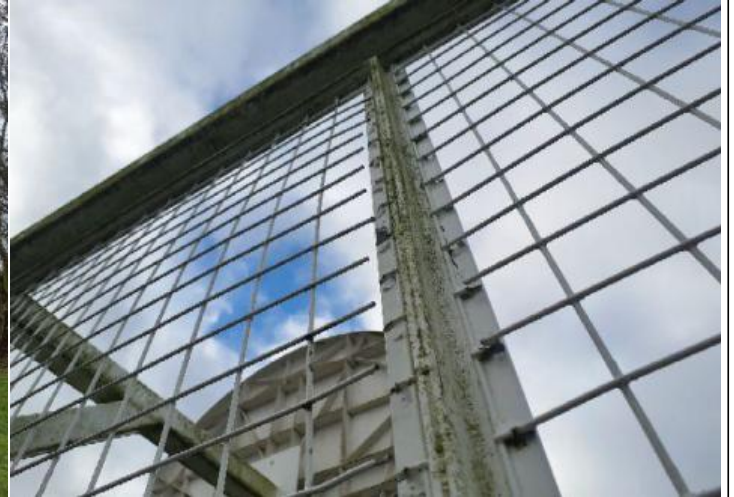
Finding: The weld(s) on this item have failed

Action: Repair item

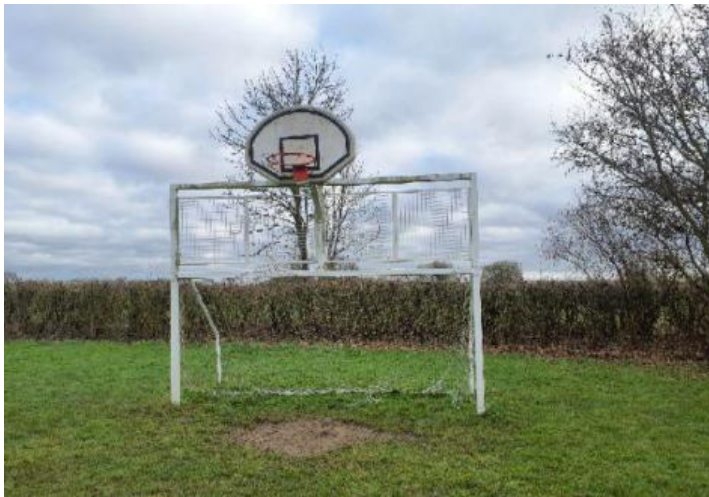
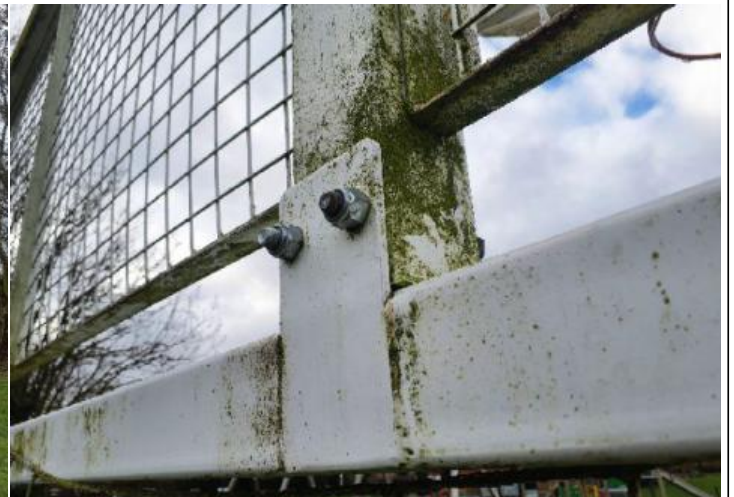
Finding: There are projecting bolt thread(s) present

Action: Remove excess thread length and deburr or provide cap

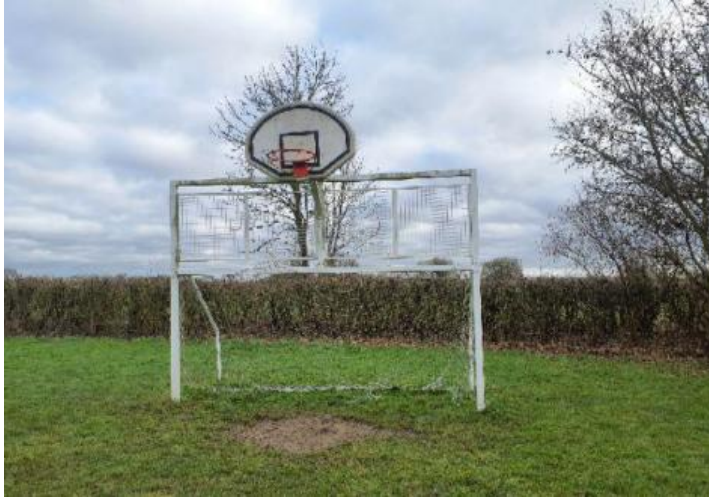
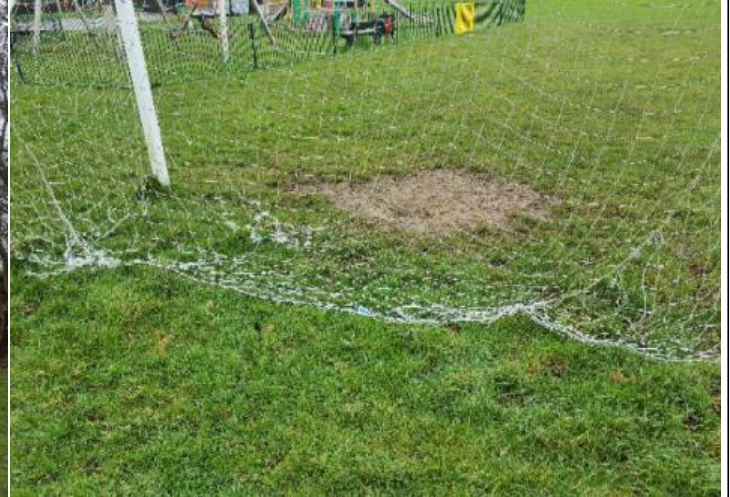
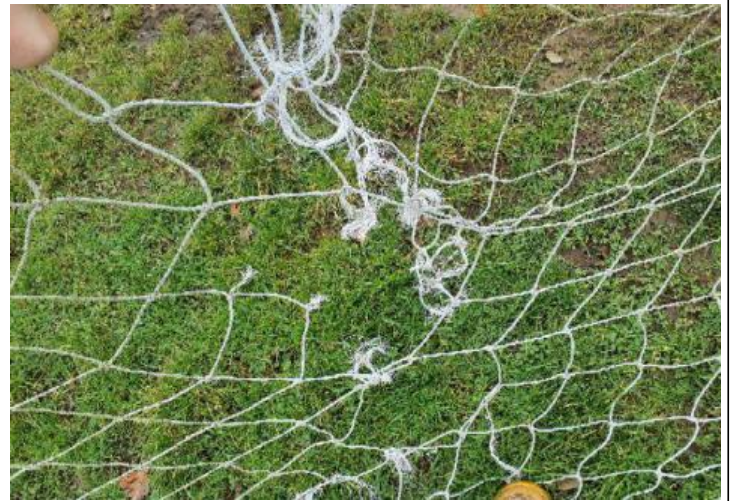
Finding: The net is damaged and unsecured

Action: Replace damage net and secure fully

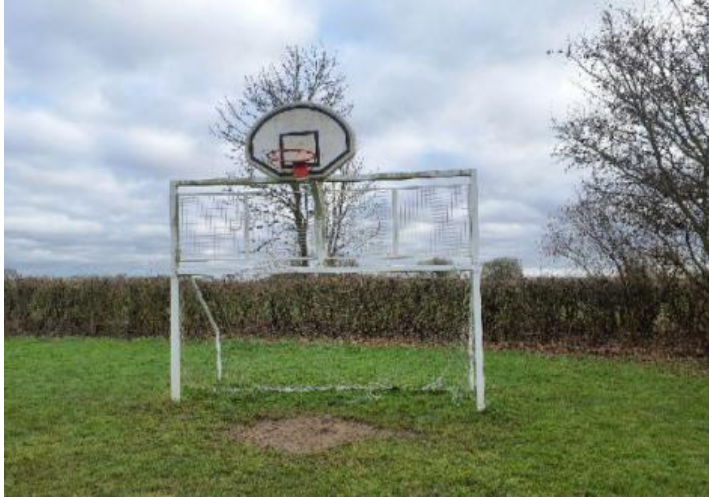
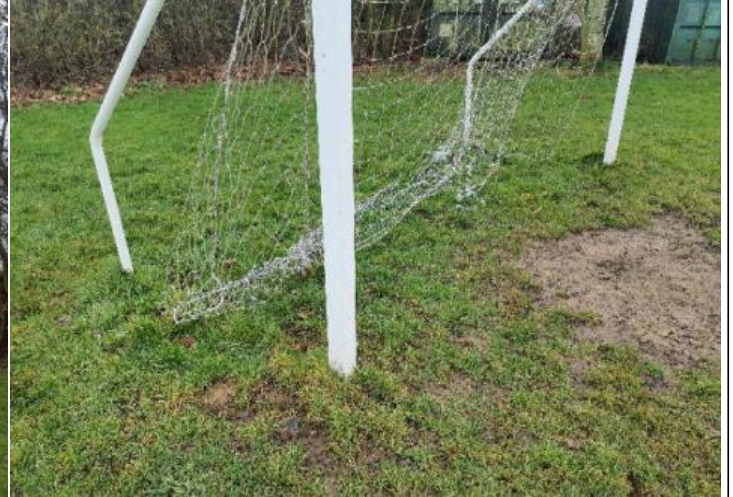
Finding: The item is slightly loose in its foundations

Action: Monitor for any further deterioration and repair as required
