the **play inspection** company

Annual Inspection

Ringshall Village Hall

Inspection Ref: 2606211

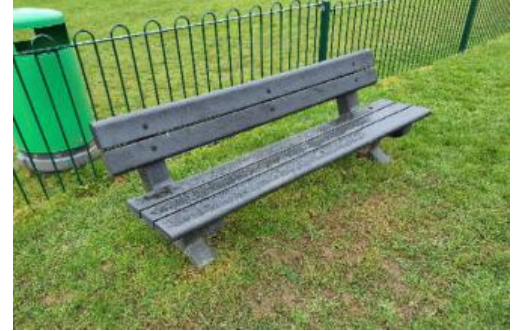
Item: Bench
Manufacturer: Glasdon
Surface Type: Grass
Item Quantity: 2
Equipment Compliance: N/A
Surface Area Compliance: N/A

Finding 1

This item is satisfactory - no work required -

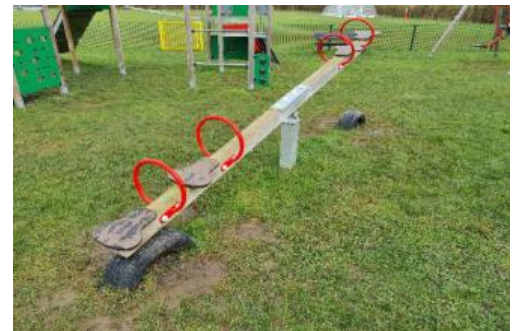
Item: See Saw
Manufacturer: Kompan Ltd
Surface Type: Grass Matrix Tiles
Item Quantity: 1
Equipment Compliance: Yes
Surface Area Compliance: Yes
Life Expectancy: 5 -10 Years
Total Findings: 1

Finding 1

This item is satisfactory - no work required -

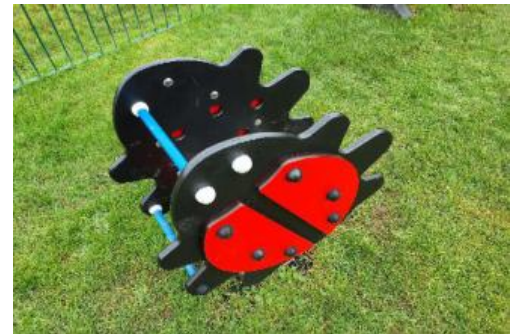
Item: Spring Ladybird
Manufacturer: Kompan Ltd
Surface Type: Grass Matrix Tiles
Item Quantity: 1
Equipment Compliance: Yes
Surface Area Compliance: Yes
Life Expectancy: 5 -10 Years
Total Findings: 1

Finding 1

This item is satisfactory - no work required -
